Storm Damage Report

Brabo International

12122 Jef Drive
Laredo, TX 78045

FIELD REPORT FOR INITIAL STORM DAMAGE INVESTIGATION

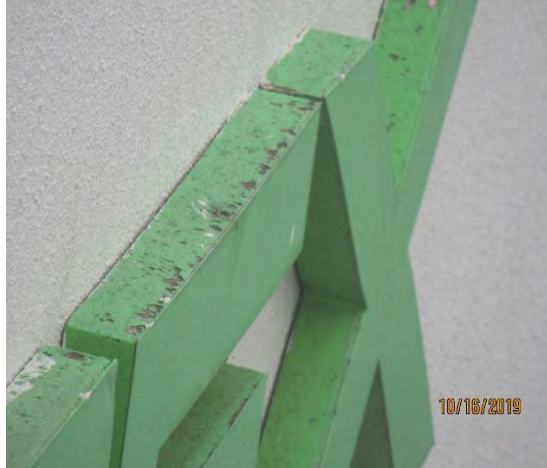
Close-up of previous photo

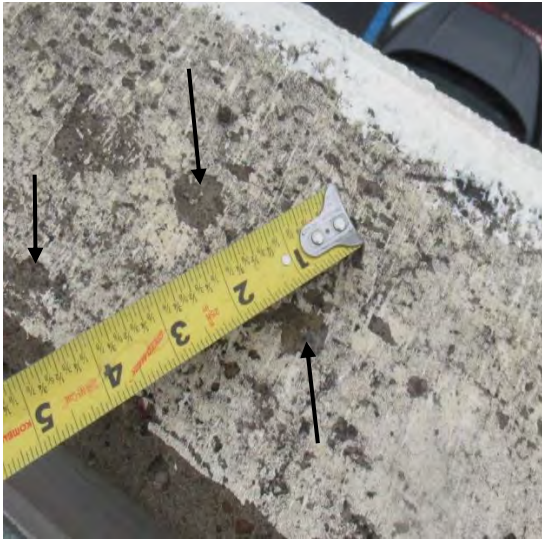
Hail impact on parapet wall

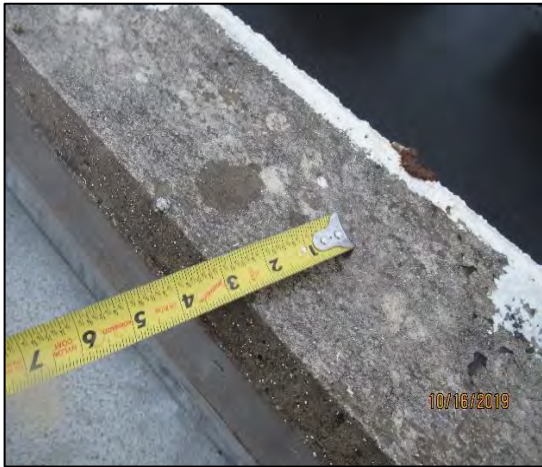
Hail impact chipped concrete on parapet

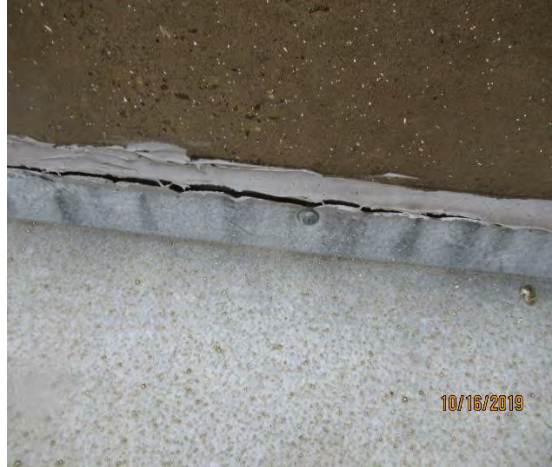
Flashing separation at panel uplift

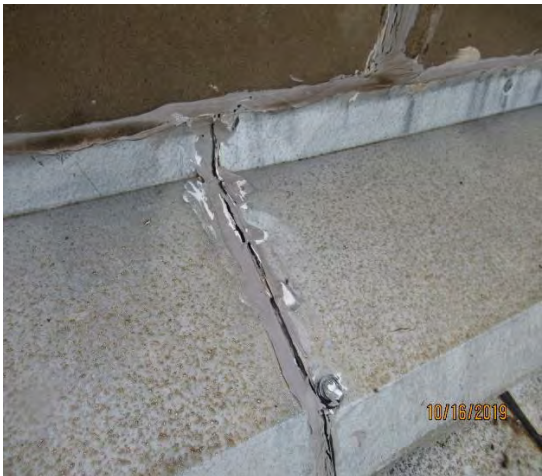
Panel shift at wall flashing

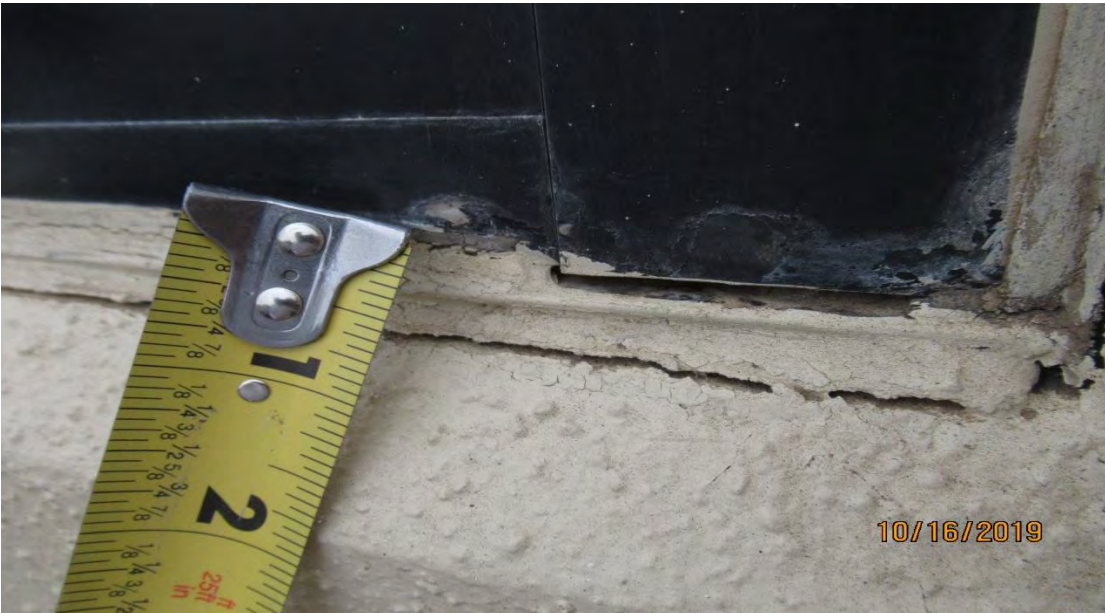
Window frame separation

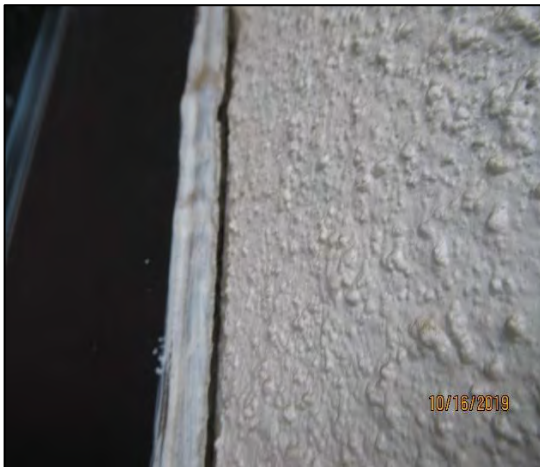
Frame to opening separation

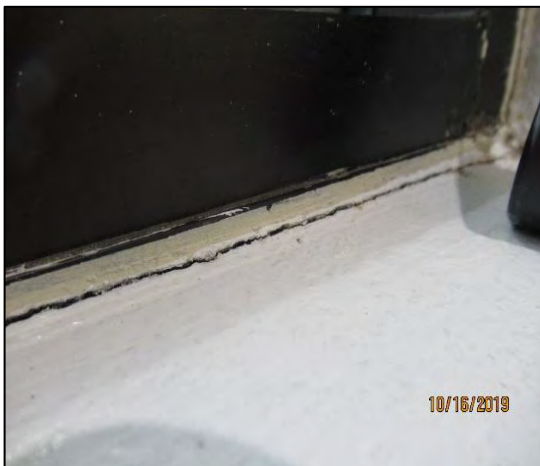
Window frame displacement

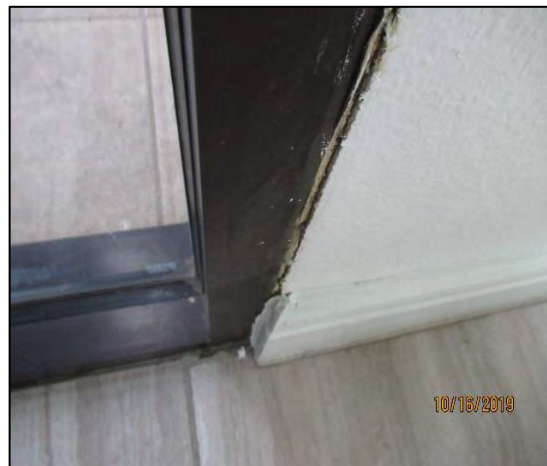
Wall to frame is displaced

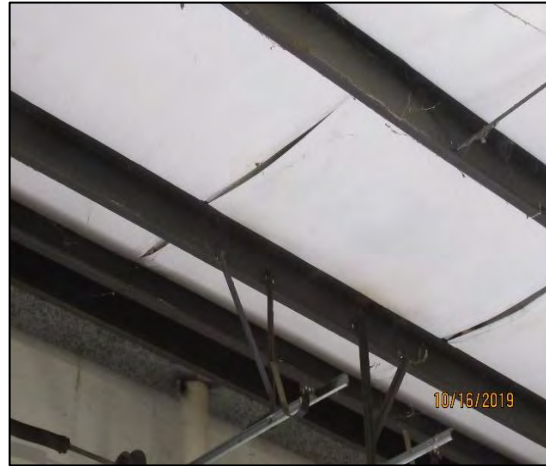
Displaced insulation

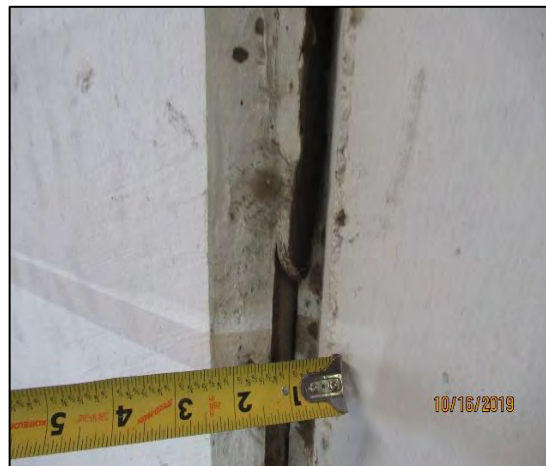
Close-up of previous photo

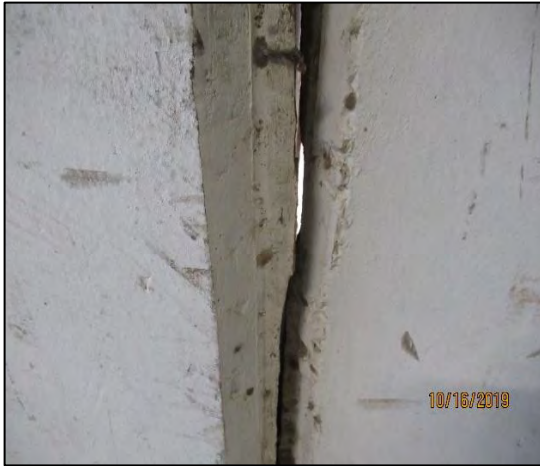
Light showing through wall joint

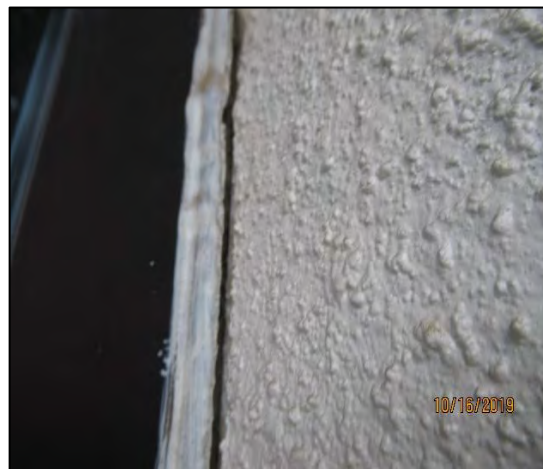
Window frame is displaced to wall

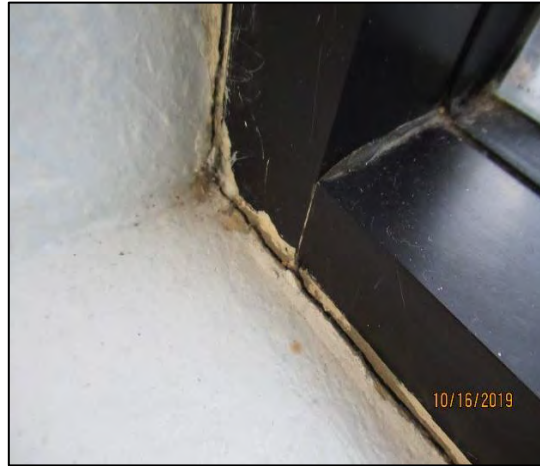
Window frame is displaced
